Re: Project Notification Form – Phase II Demolitions – Uniroyal Complex, 154 Grove Street  
and Facemate Complex, 5 West Main Street, Chicopee, MA

**PROJECT NOTIFICATION FORM**

Project Name Uniroyal/Facemate Complex – Phase II Demolitions  
Location / Address 154 Grove Street (Uniroyal) and 5 West Main Street (Facemate)  
City / Town Chicopee Falls, MA 01020  
Project Proponent  
Name Thomas Haberlin, Economic Development Director, Office of Community Development  
Address 17 Springfield Street  
City / Town Chicopee, MA 01013  
Telephone # (413) 519-7167

Uniroyal/ Facemate Complex  
Phase II Demolitions  
Chicopee, MA

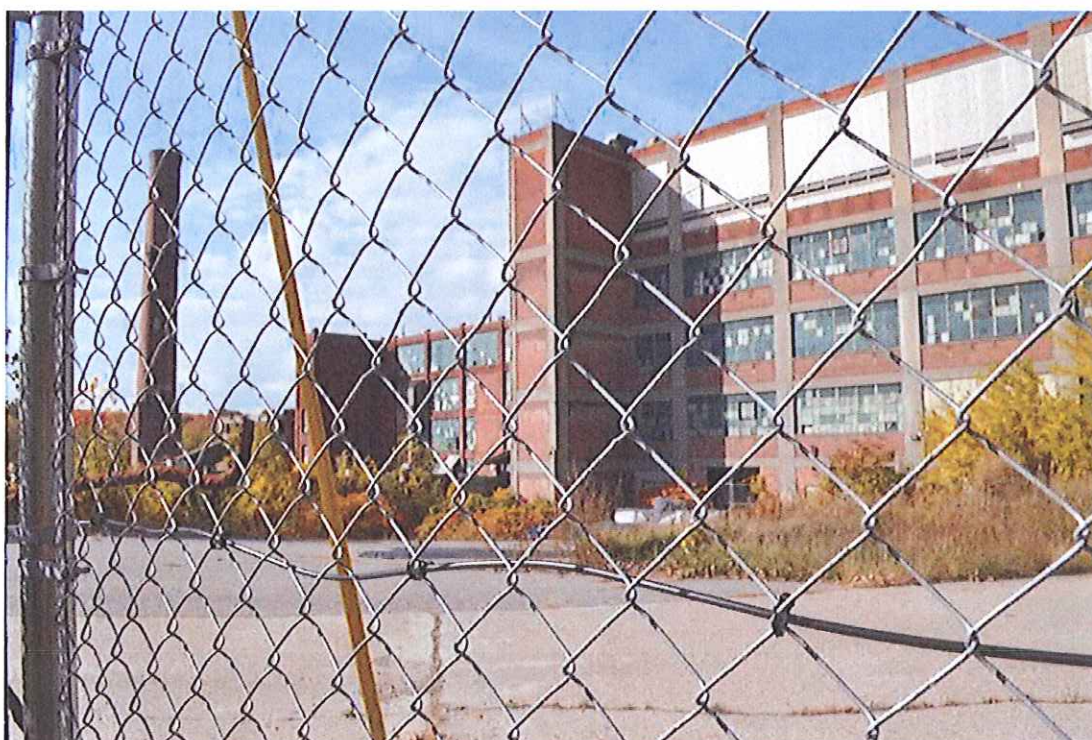
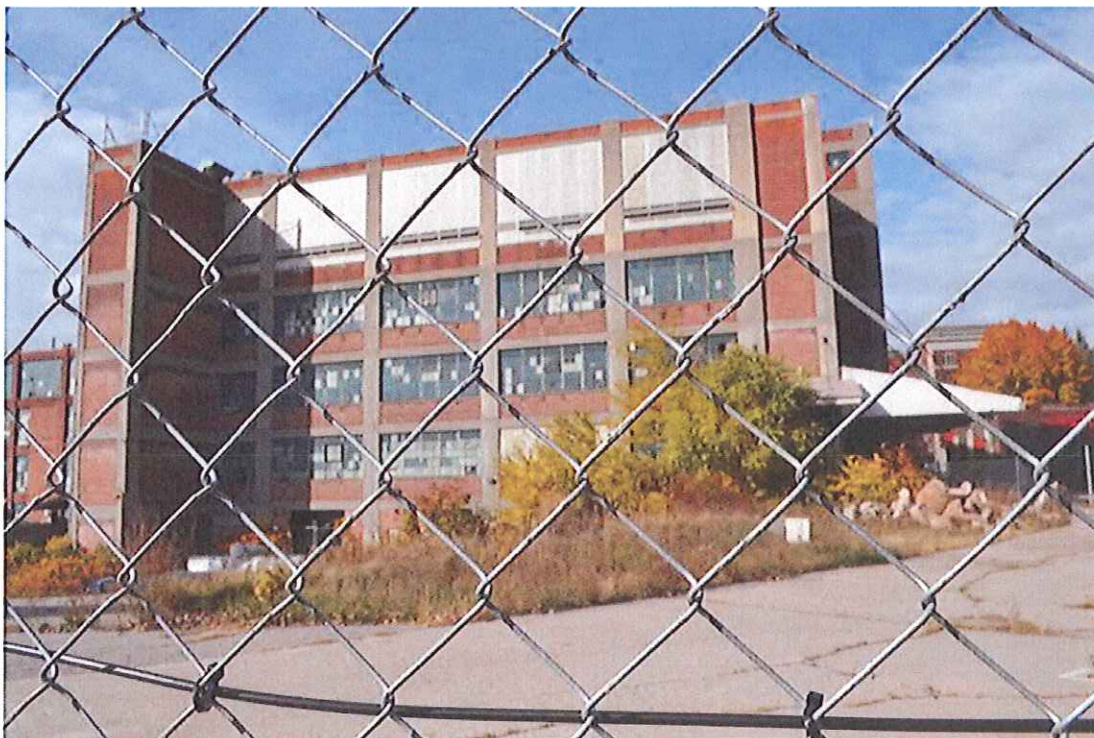
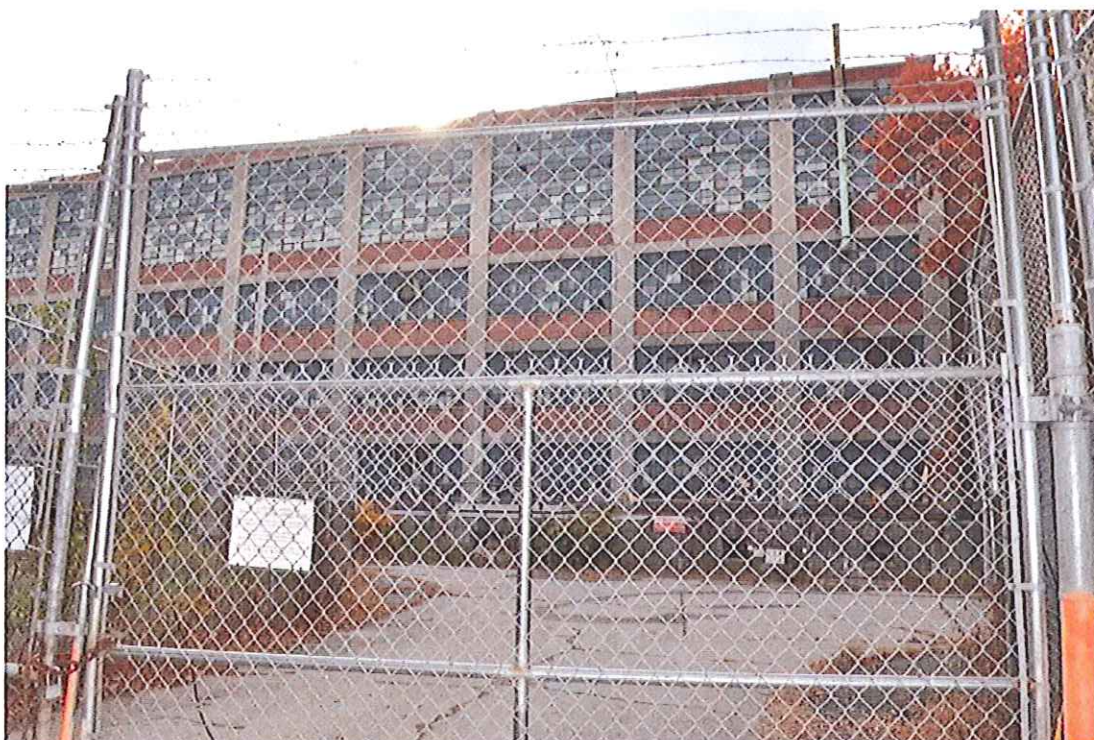
**Building #42** (Photograph #22, 23 and 24) is a massive, 5-story concrete pier and brick spandrel building, similar to Building #27 to which it is connected, but has much larger window openings with multiple pane industrial sash.

**22. Building #28 (on left) and #42 (on right) Uniroyal Complex, 154 Grove Street, Chicopee, MA. View of south elevations, Photographer facing NW, October 2010**

**23. Building #42, Uniroyal Complex, 154 Grove Street, Chicopee, MA. View of south elevation, Photographer facing N, October 2010**

**24. Building #42, Uniroyal Complex, 154 Grove Street, Chicopee, MA. View of east elevation, Photographer facing W, October 2010**

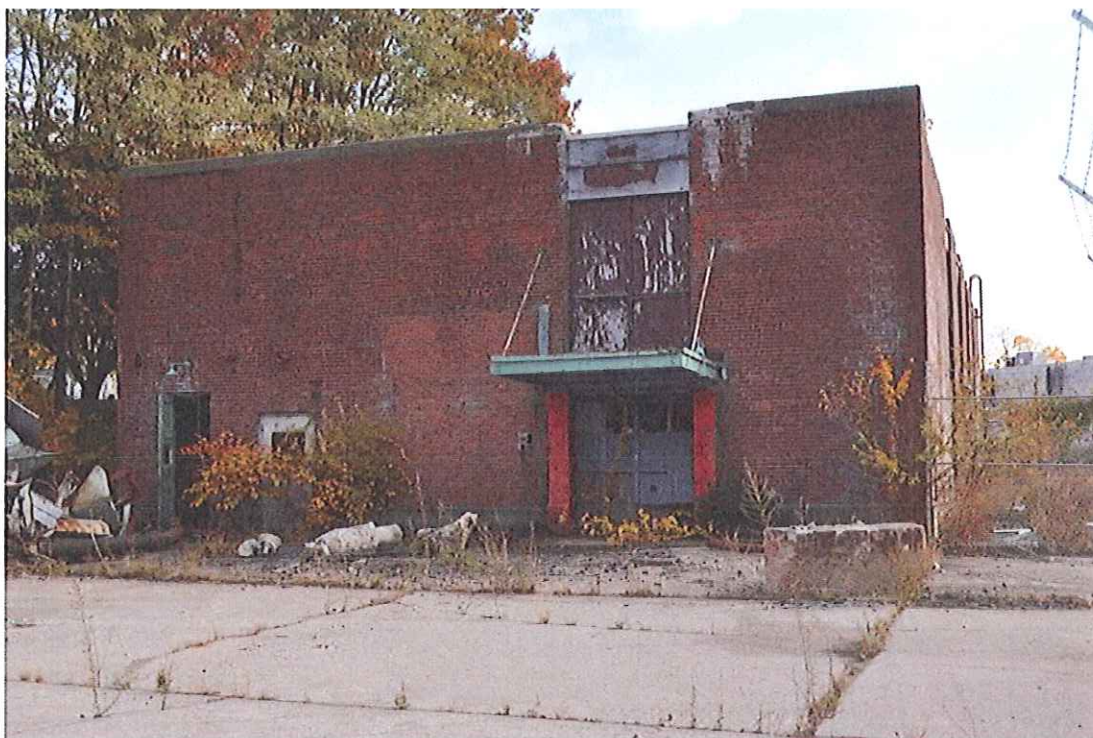
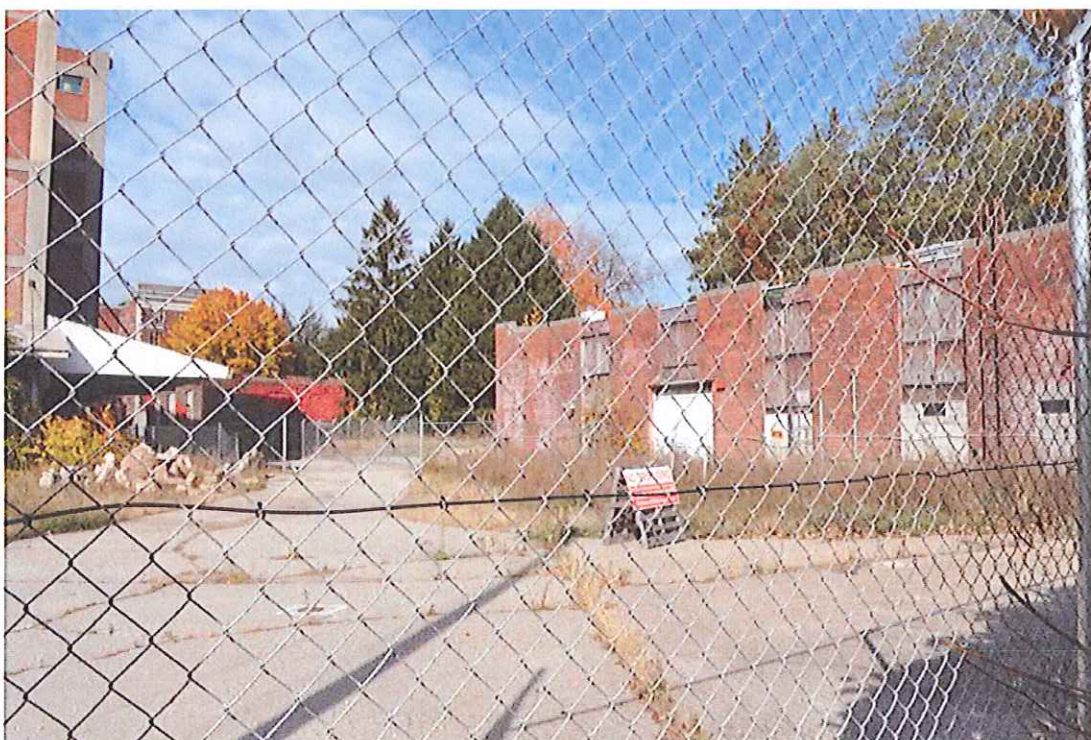
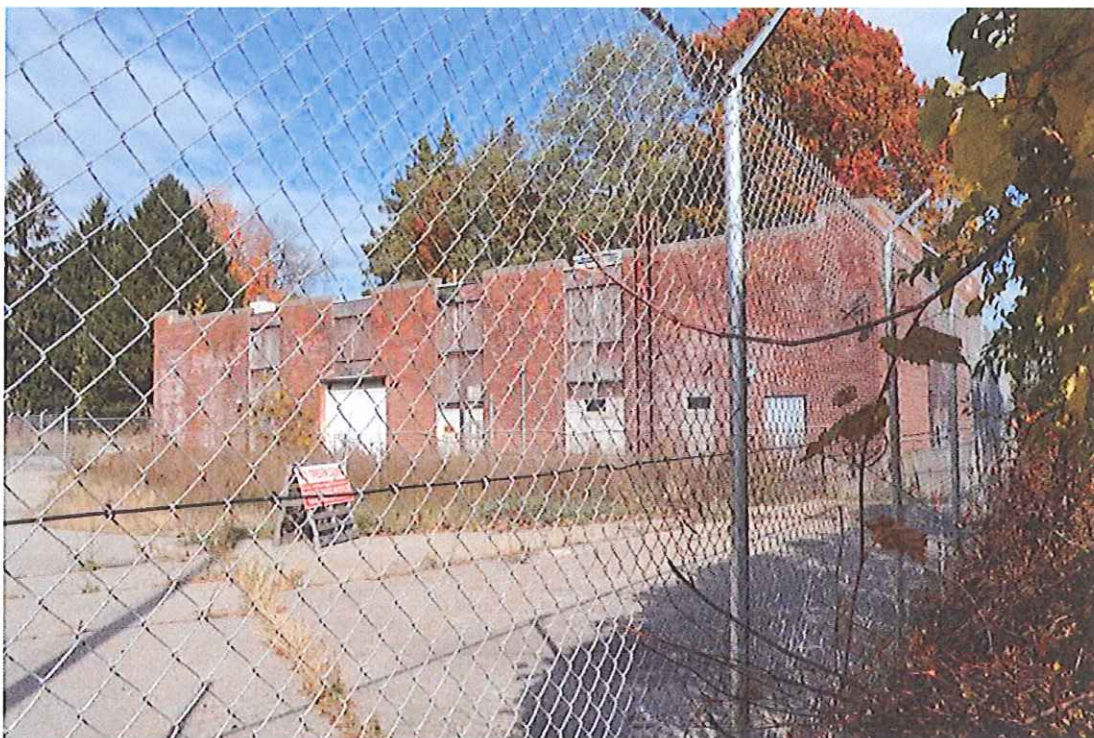
**Building #43** (Photograph #25, 26 and 27) is a 2-story, flat-roofed brick rectangular plan structure with concrete coping at the top of the parapet wall on all four sides. The large window openings are contained in slightly recessed areas between wide brick sections.

**25. Building #43, Uniroyal Complex, 154 Grove Street, Chicopee, MA. View of north elevation, Photographer facing S, October 2010**

**26. Building #43 on right, Uniroyal Complex, 154 Grove Street, Chicopee, MA. View of west elevation, Photographer facing NE, October 2010**

**27. Building #43, Uniroyal Complex, 154 Grove Street, Chicopee, MA.** View of west and south elevation, Photographer facing E, October 2010

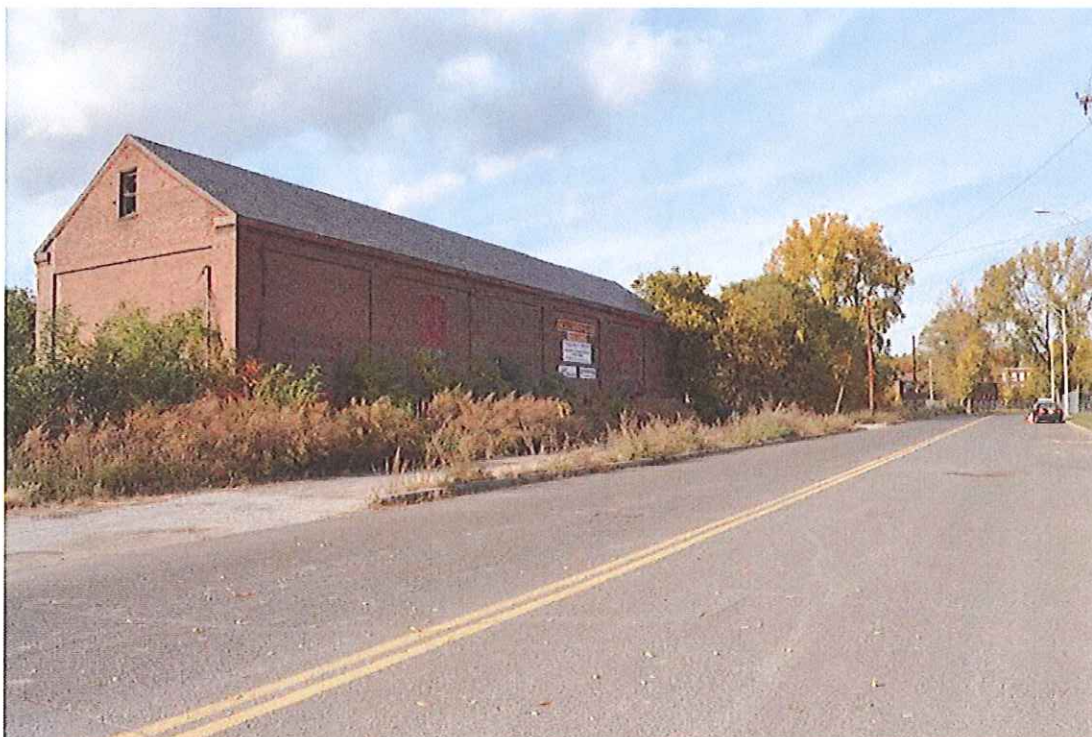
**28. Building #1, Facemate Complex, 5 West Main Street, Chicopee, MA.** View of south and east elevation, Photographer facing NW, October 2010

A Phase 2 structural evaluation of Building #1, Building #3, and the Stair Tower Building section of Building #5 of the Facemate complex and Building #26 of the Uniroyal complex was subsequently prepared by BETA Group, Inc. in August 2010. An addendum to this report was prepared in September 2010, which reassessed these buildings with the newly-issued Eighth Edition of the Commonwealth of Massachusetts' Commercial Building Code. The initial evaluation (see Executive Summary on page 3 of the August 2010 study) found that three of the four buildings (Building #1 and the Stair Tower Building section of Building #5 in the Facemate complex and Building #26 of the Uniroyal complex) were possible candidates for reuse, although costs were relatively high for upgrades on some due to structural/condition issues. These initial evaluations regarding reuse/redevelopment costs were solidified in the addendum report (see page 1 of the September 2010 study), as the costs for rehabilitation of Building #3 (the Clock Tower Building) are now even higher as the result of the updated Massachusetts building code.

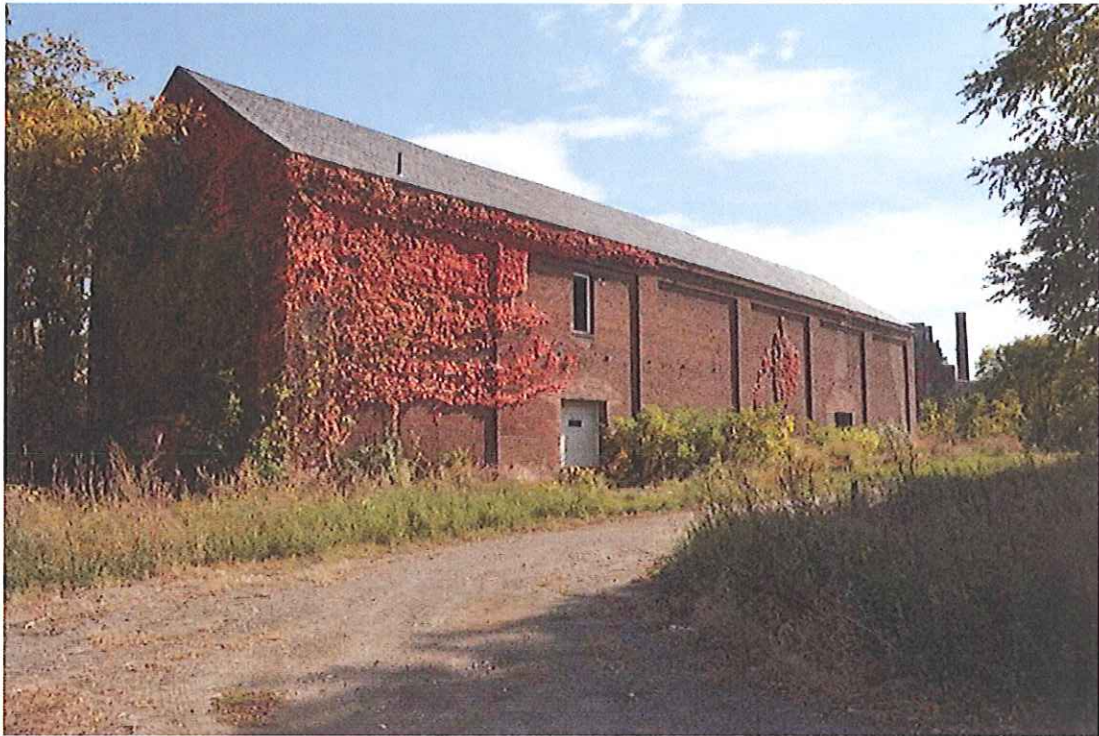
**29. Building #1, Facemate Complex, 5 West Main Street, Chicopee, MA.** View of north and west elevation, Photographer facing SE, October 2010

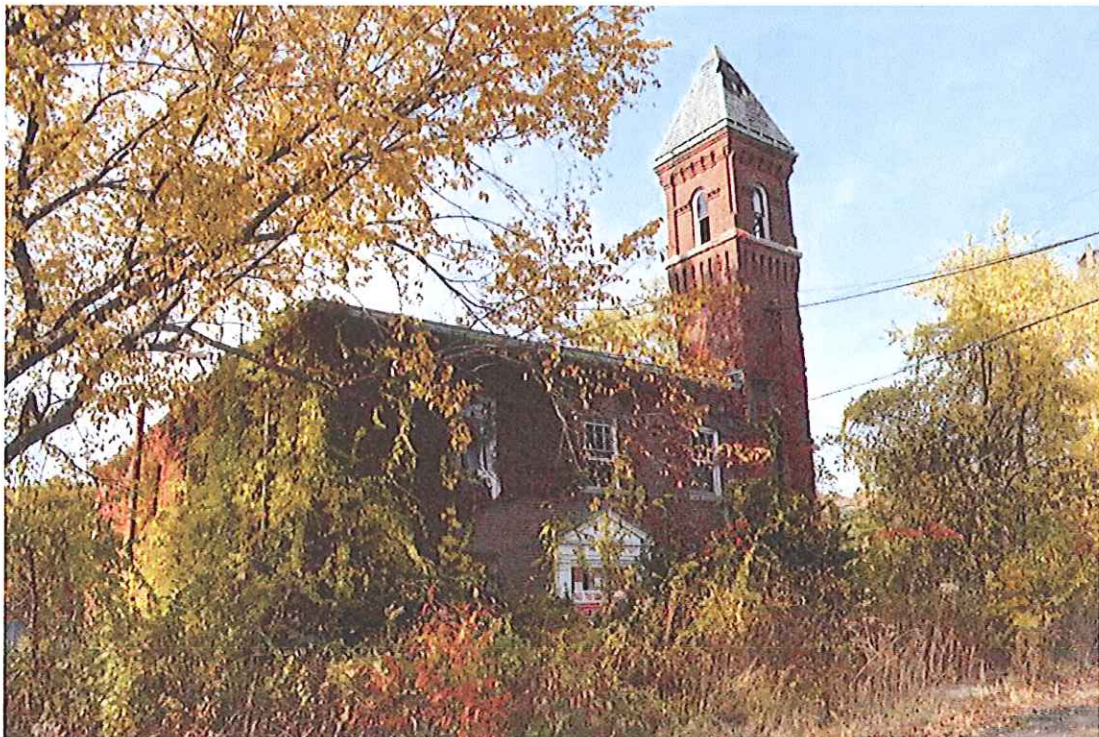
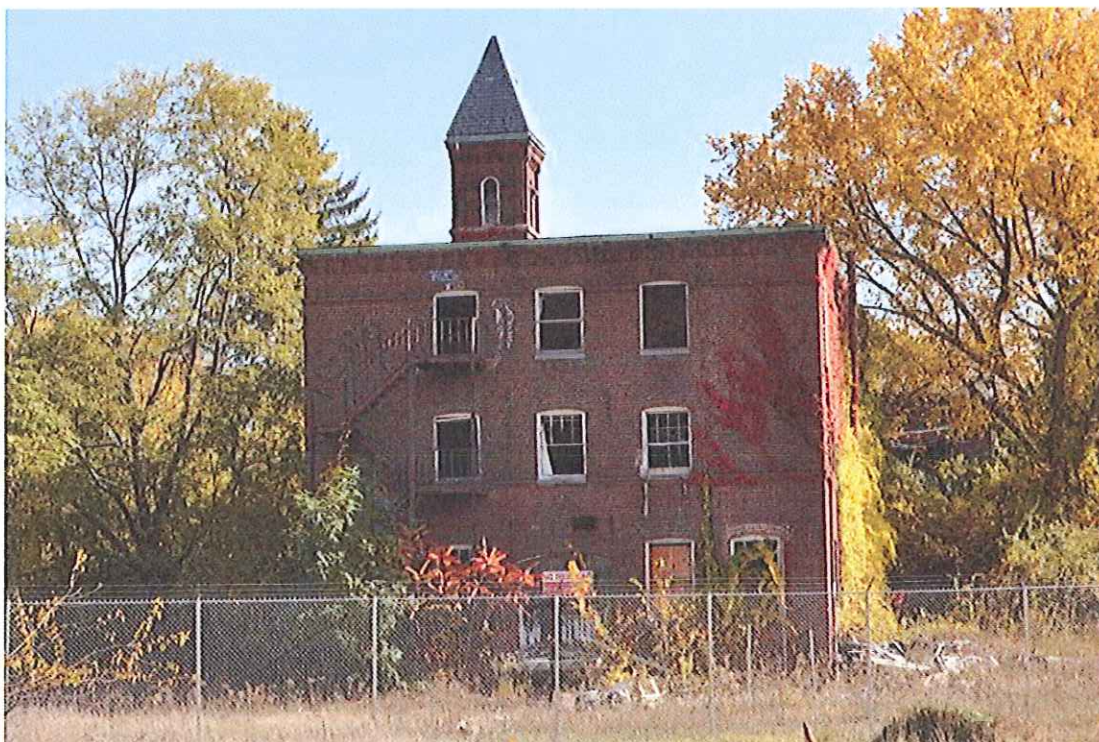
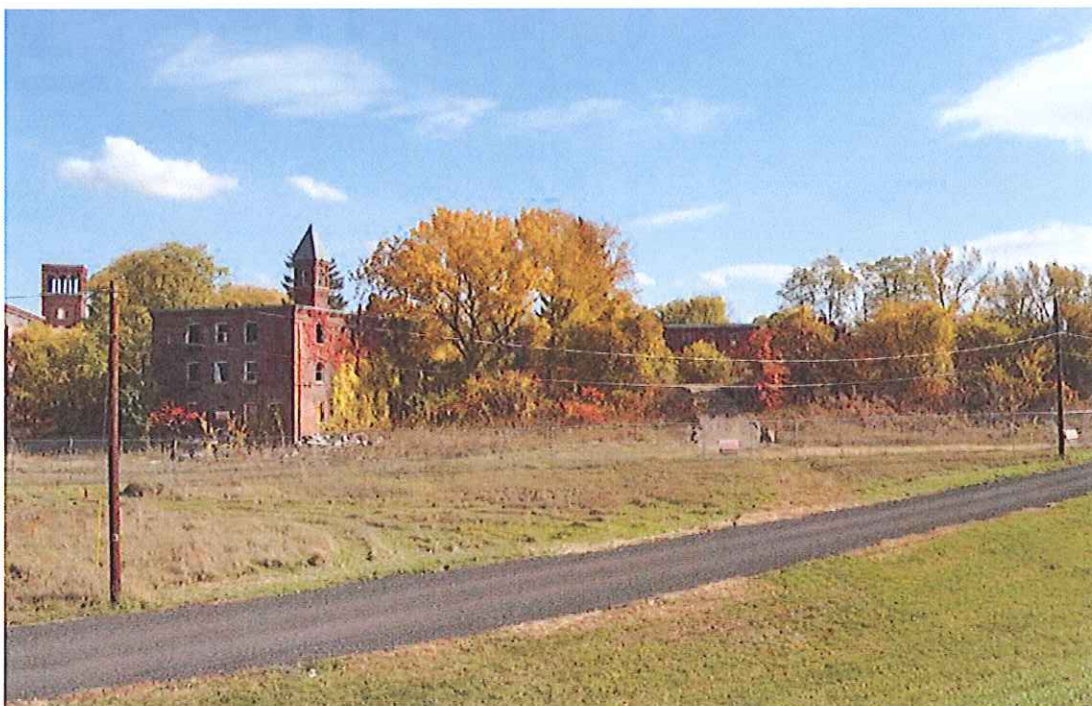
**Building #3 (Clock Tower Building)** (Photograph #30, 31 and 32) served as the administration building for the Chicopee Manufacturing Company and is estimated to date to the 1870s. The 2-story, flat-roofed brick building has a narrow stair tower with a steeply-pitched pyramidal roof at the northeast corner.

**30. Building #3, Facemate Complex, 5 West Main Street, Chicopee, MA.** View of front (east) and partial south elevation, Photographer facing NW, October 2010

**31. Building #3, Facemate Complex, 5 West Main Street, Chicopee, MA. View of rear (west) elevation, Photographer facing SE, October 2010**

**32. Building #5 central stair tower (left), Building #3, and rear of Building #12 , Facemate Complex, 5 West Main Street, Chicopee, MA. View of west side of complex, Photographer facing SE, October 2010**

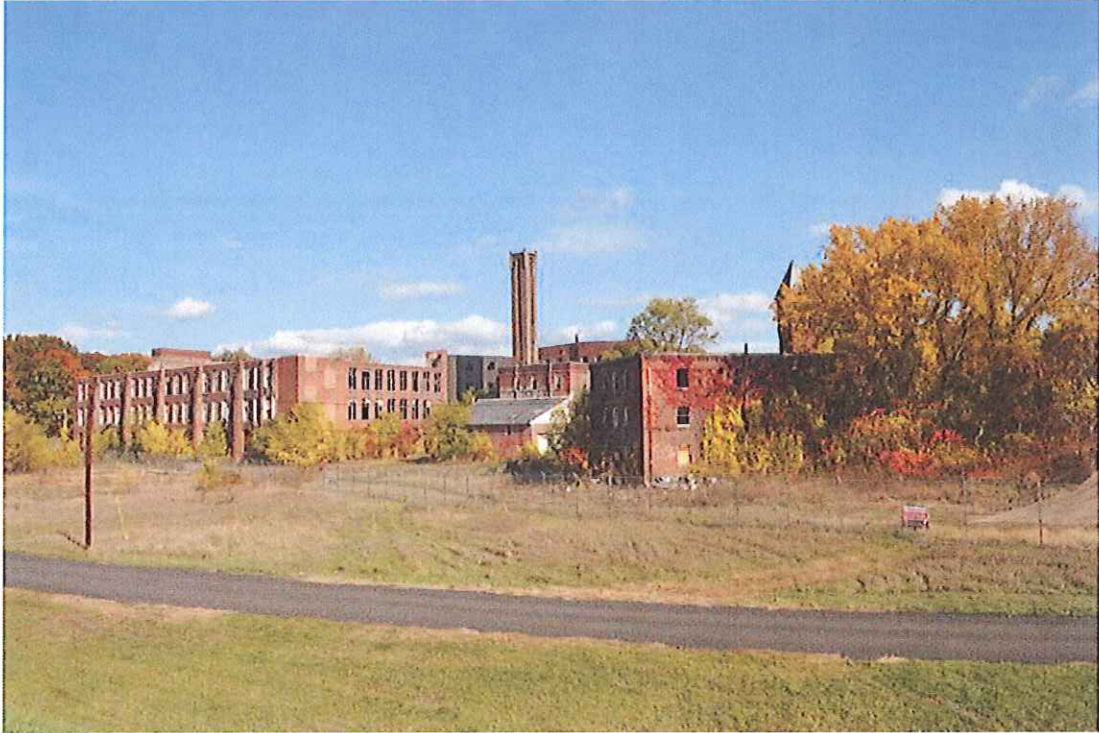
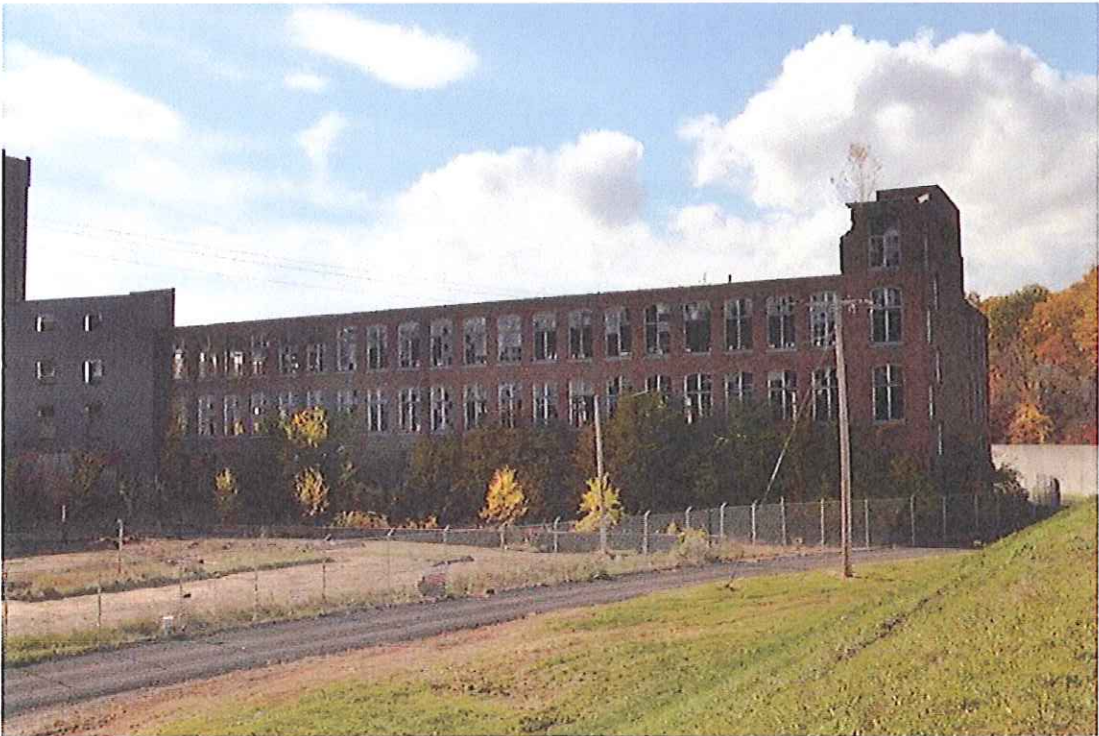
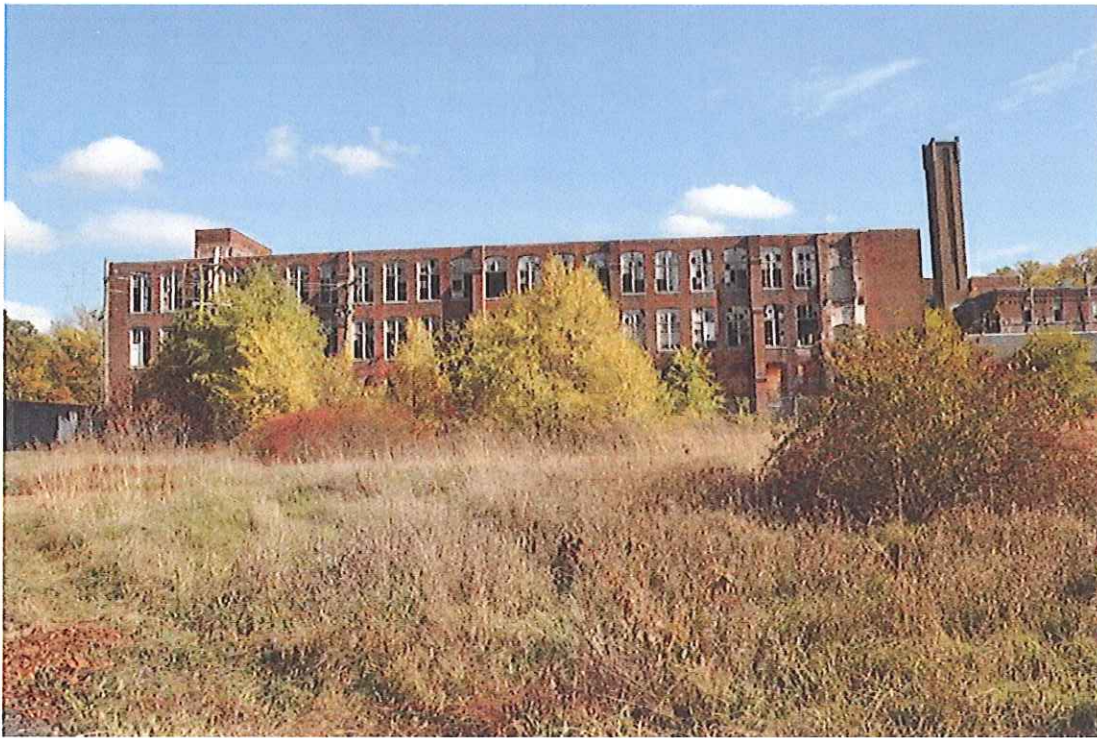
**Building #4** (Photograph #33, 34 and 35) is a 3-story brick building (originally No. 5 Mill, estimated to date to the mid-1870s) with a long rectangular plan and flat roof; the building is connected to Building #5 via a narrow, 4-story west end connector, which forms an L-shaped footprint in the north end of the Facemate complex. The building's east elevation displays a series of closely-spaced, segmental arched window openings. Stepped brick buttresses on the west elevation define a series of bays which contain groups of three and four window openings which also have segmental arched tops.

**33. Building #4 (on left), Building 5B (west additions ) in center, and Building #3, Face-  
mate Complex, 5 West Main Street, Chicopee, MA. View of west side of complex, Photog-  
rapher facing NE, October 2010**

**34. Building #4, Facemate Complex, 5 West Main Street, Chicopee, MA. View of east ele-  
vation, Photographer facing W, October 2010**

**35. Building #4, Facemate Complex, 5 West Main Street, Chicopee, MA.** View of west elevation, Photographer facing E, October 2010

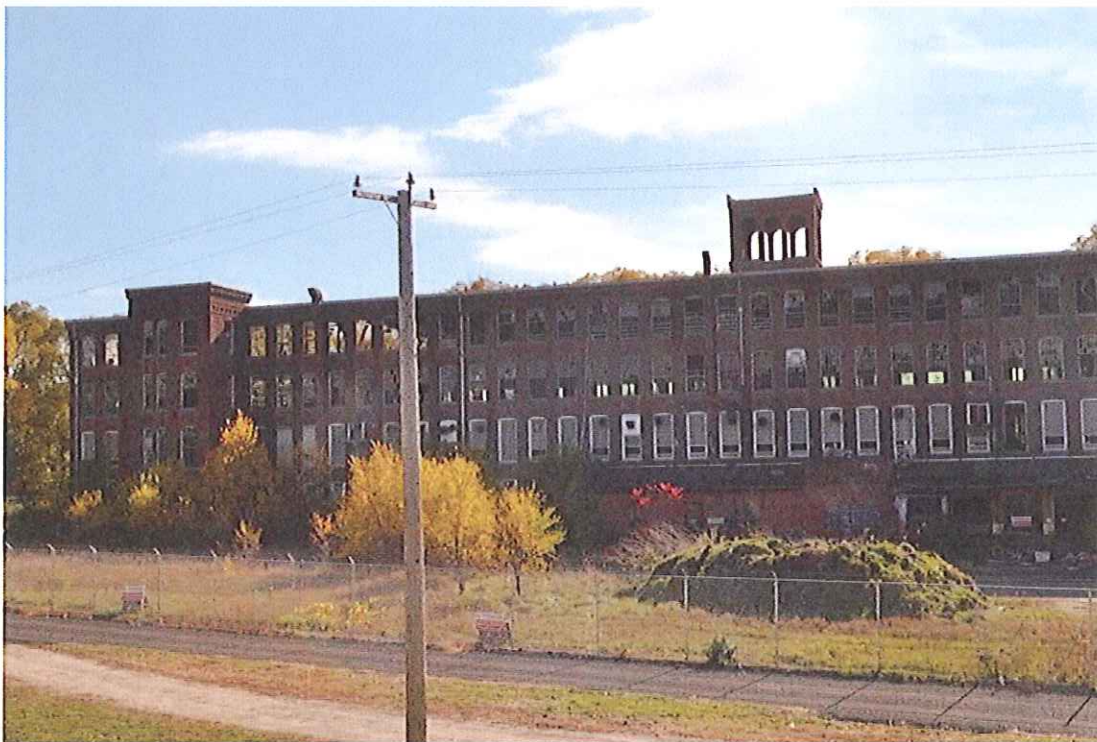
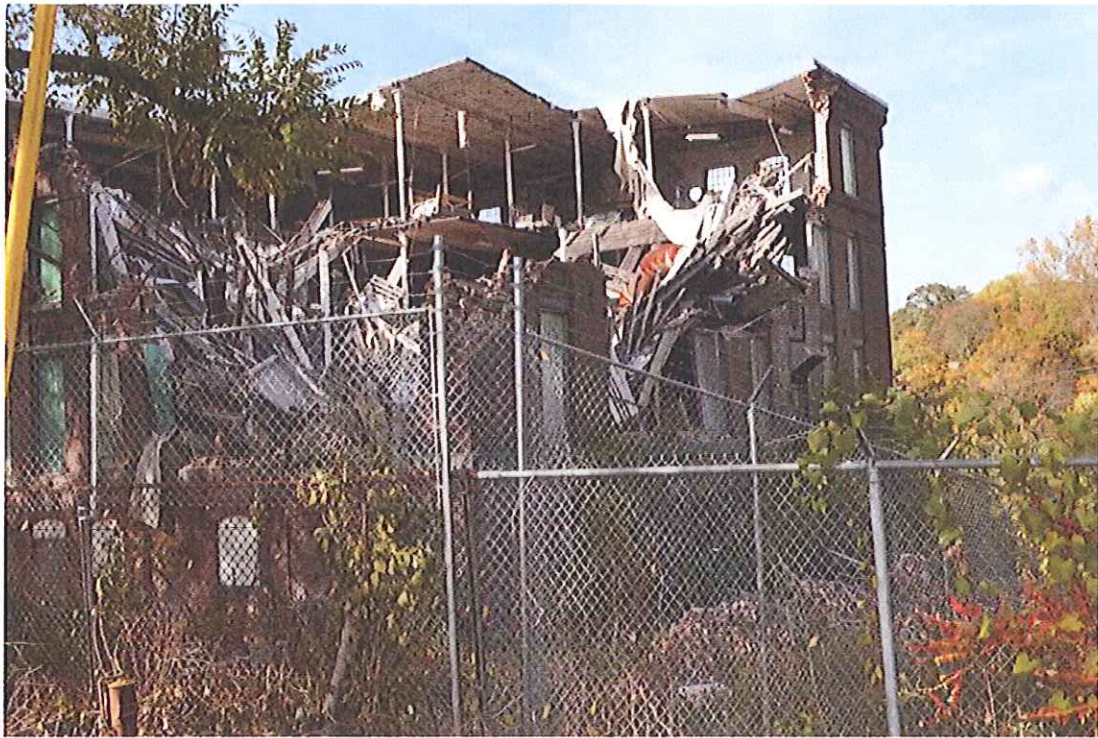
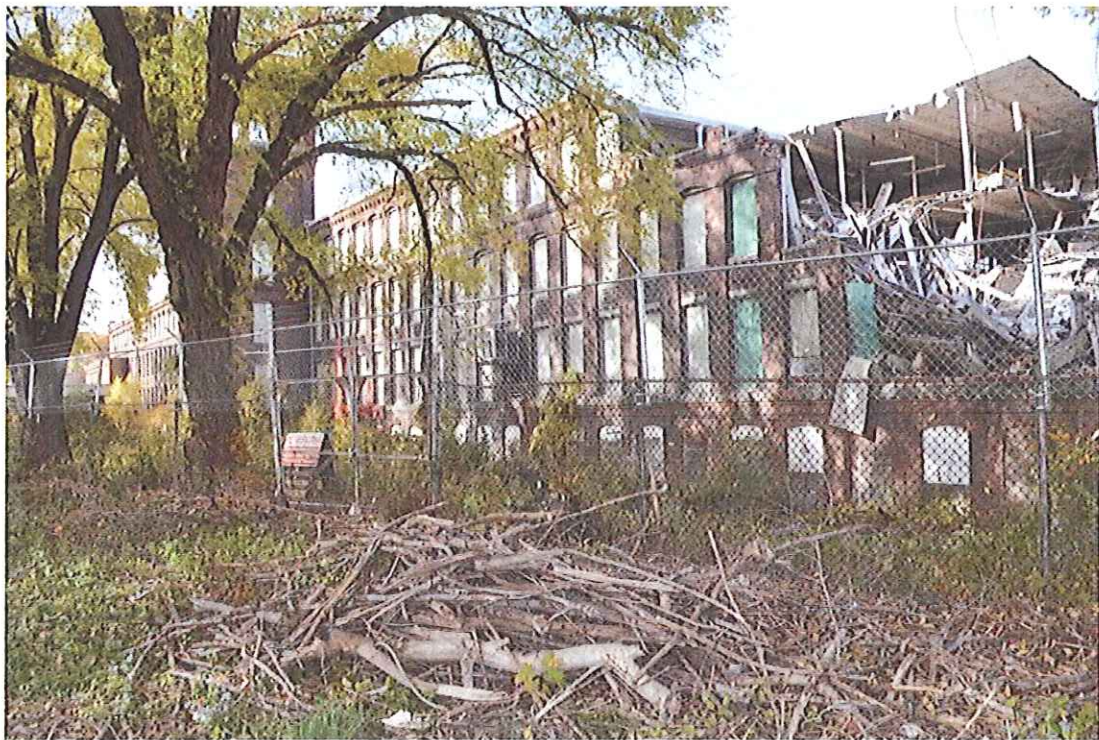
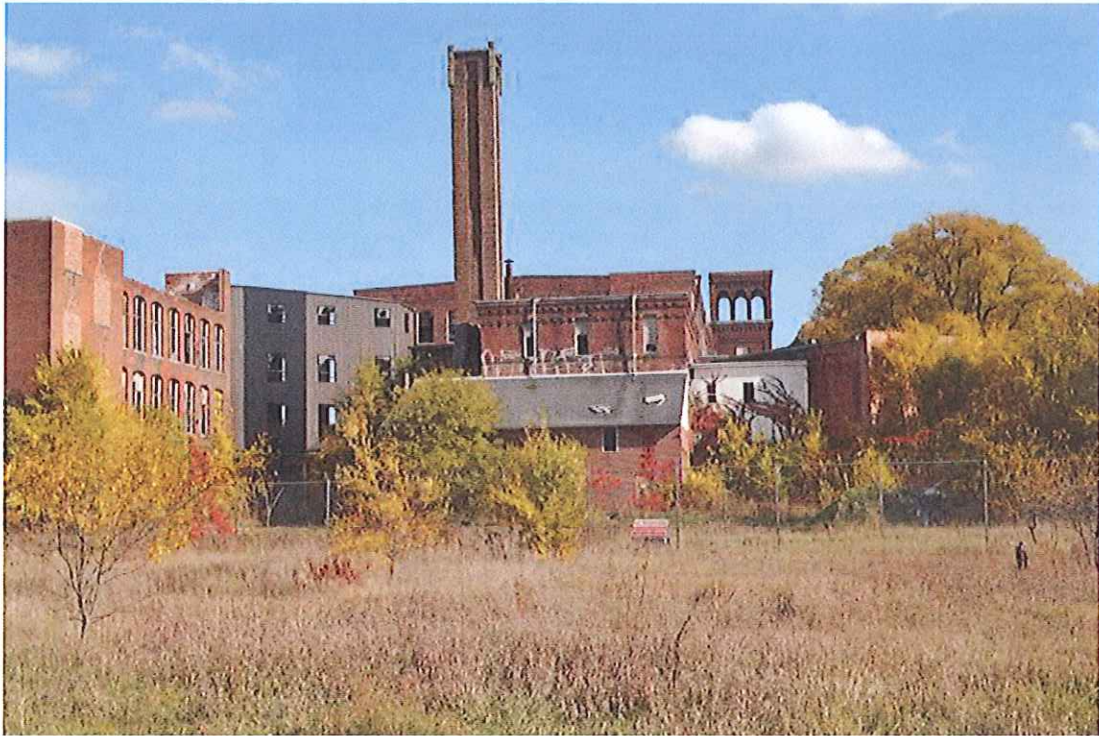
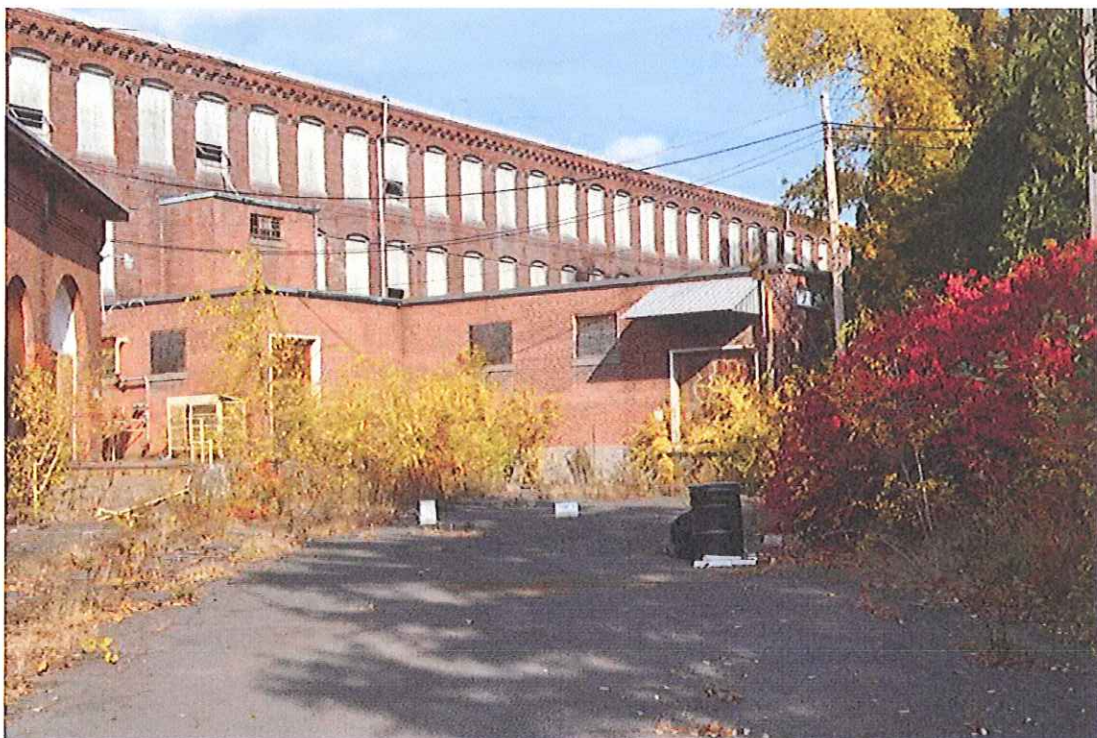
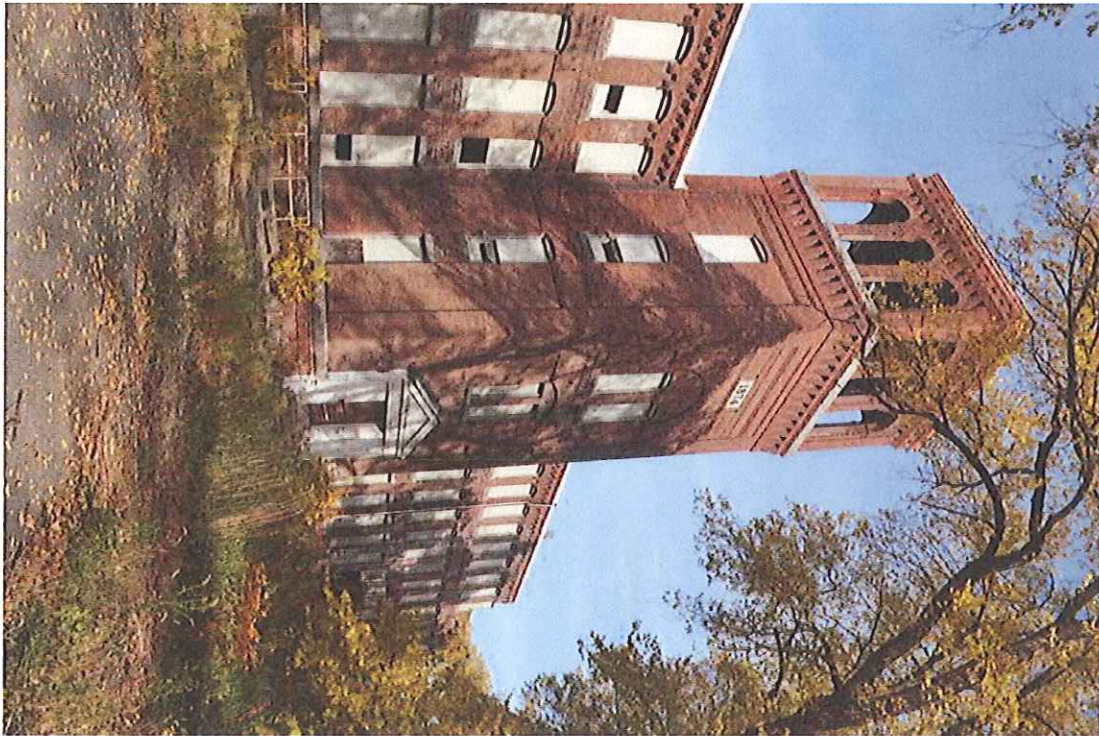
**Building #5/5B** (Photograph # 36, 37, 38, 39 and 40) is a 4-story brick building (originally No. 1, Main Mill, dating to 1874), which also has a long rectangular plan and flat roof. The building features a central projecting brick tower (called the Stair Tower section in the BETA, Inc. reports) on the front (south) elevation, which is not proposed for demolition. Two narrow brick stair towers project from the north elevation. The east end of the building has collapsed. A series of 1-story brick additions and a 4-story metal siding-clad connector to Building #4 at the west end of this building are collectively called Building #5B in the Tighe & Bond May 2010 Phase I report.

**36. Building #5, Facemate Complex, 5 West Main Street, Chicopee, MA.** View of north elevation, Photographer facing S, October 2010

**37. Building # 5, Facemate Complex, 5 West Main Street, Chicopee, MA.** View of east and elevation, Photographer facing NW, October 2010

**38. Building #5, Facemate Complex, 5 West Main Street, Chicopee, MA.** View of south (front) elevation, Photographer facing NW, October 2010

**39. Building #4 on left and Building #5 and its additions (#5B) on right, Facemate Complex, 5 West Main Street, Chicopee, MA. View of west elevations, Photographer facing E, October 2010**

**40. Building # 5 and additions on west side (#5B), Facemate Complex, 5 West Main Street, Chicopee, MA. View of south elevation, Photographer facing NE, October 2010**

**41. Stair Tower section of Building #5, Facemate Complex, 5 West Main Street, Chicopee, MA.** View of stair tower on south (front) elevation, Photographer facing NW, October 2010

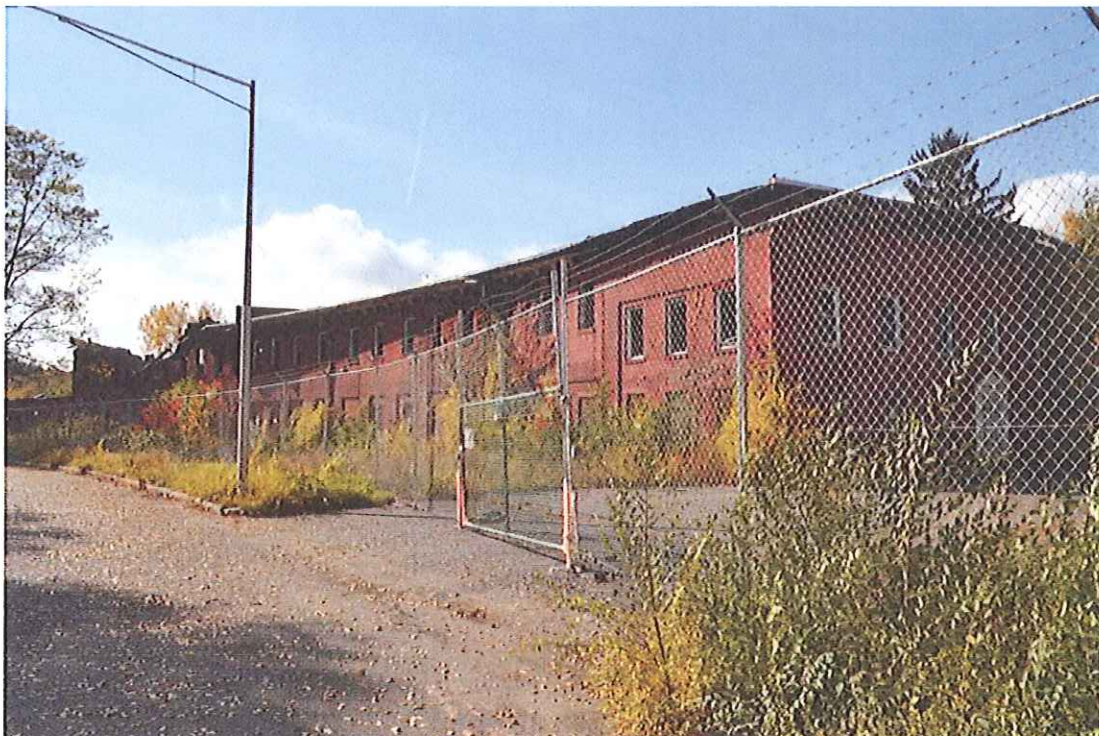
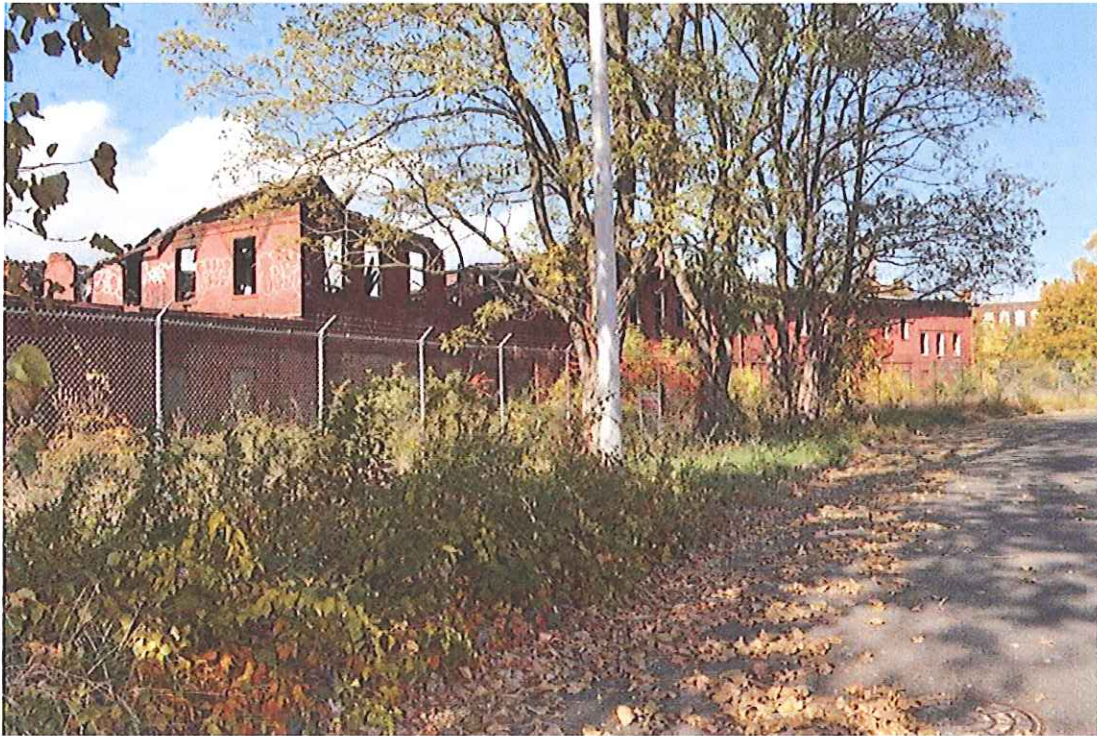
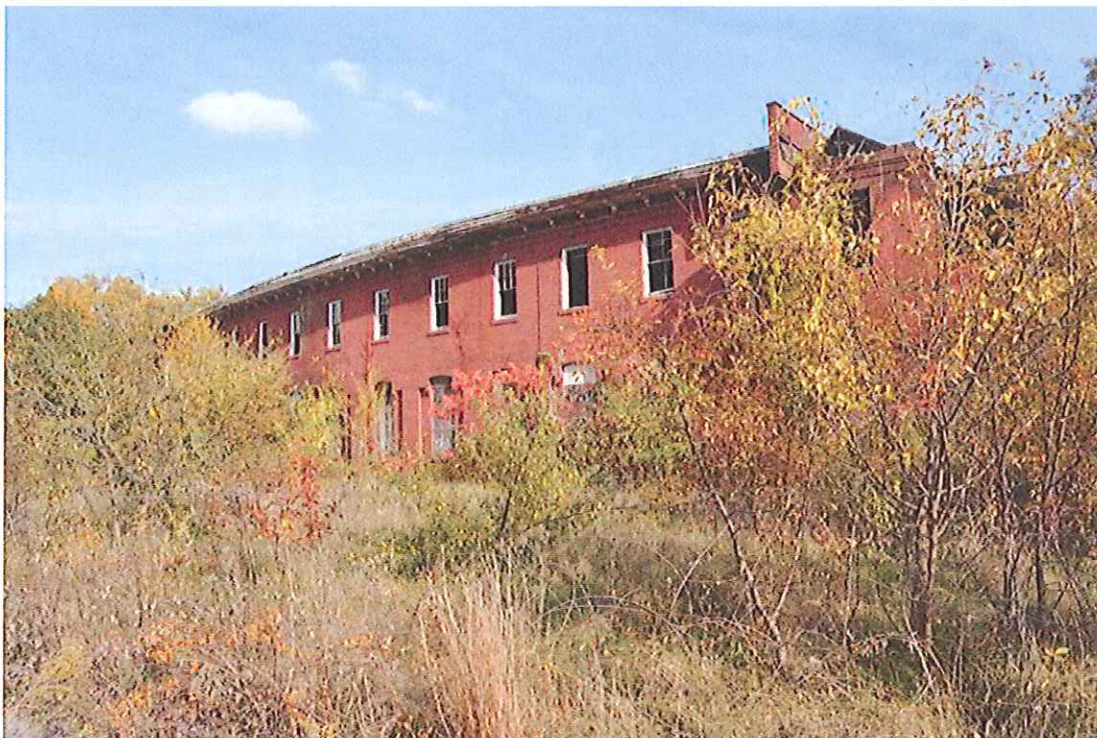
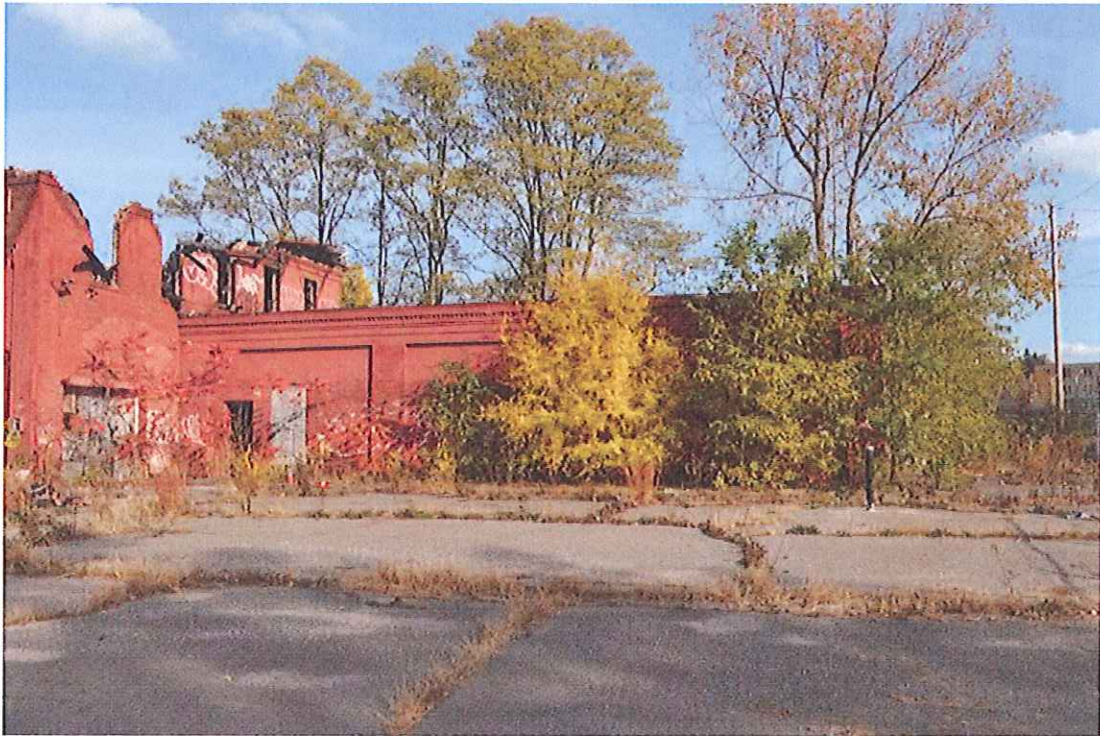
**Building #12** (noted as Building #2 in the Tighe & Bond May 2010 Phase I report) (Photograph #42, 43, 44 and 48) is a long, semi-circular 2-story building (originally No. 2 Storehouse and estimated to date to c. 1880)

with a small, 1-story rectangular addition on the south end. The brick structure has a series of regularly-spaced single windows on both stories of the east and west elevations. The roof and top brick sections of the building's south end are gone, due to a fire.

**42. Building #12, Facemate Complex, 5 West Main Street, Chicopee, MA.** View of east and north elevation, Photographer facing SW, October 2010

**43. Building #12 Facemate Complex, 5 West Main Street, Chicopee, MA.** View of south and east elevation, Photographer facing NW, October 2010

**44. Building #12, Facemate Complex, 5 West Main Street, Chicopee, MA.** View of north end of west elevation, Photographer facing NE, October 2010

**45. Building #12, Facemate Complex, 5 West Main Street, Chicopee, MA. View of south end of west elevation, Photographer facing E, October 2010**
